SIGAR 14-31 Inspection Report

SALANG HOSPITAL: LACK OF WATER AND POWER SEVERELY LIMITS HOSPITAL SERVICES, AND MAJOR CONSTRUCTION DEFICIENCIES RAISE SAFETY CONCERNS

**JANUARY
2014**

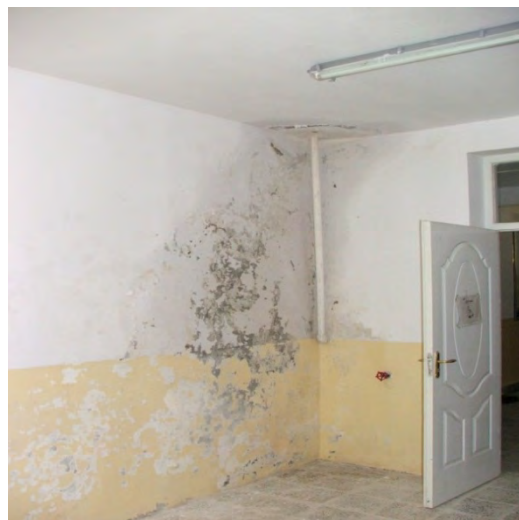
Photo 2 - Leaky Roof Damages Ceilings and Walls

- The hospital staff told us the hospital roof was leaking, causing mold and mildew on the ceiling and walls. Our inspection confirmed the presence of mold and mildew (see photo 2). The statement of work required that the concrete roof slab be hot-tarred to provide waterproofing prior to installing wooden trusses to support the corrugated metal roof. Photos contained in the contract files show that the hot-tarring was not done. Photos also show that the wooden trusses on top of the concrete slab roof were not covered with plywood and tar paper, as required. Our inspection confirmed these construction deficiencies.

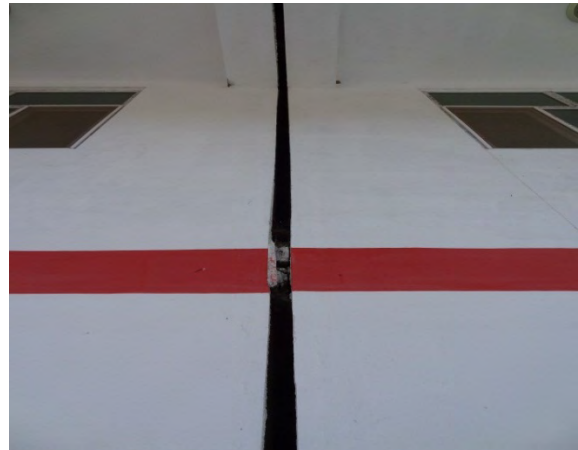
Photo 3 - Excessively Wide Expansion Joint

- First, we observed a vertical expansion joint that basically cuts the hospital structure in half (see photo 3). The gap is about 3 inches wide and has no concrete or reinforcing steel providing a connection across the joint. In essence, the hospital consists of two separate buildings under one corrugated metal roof. Due to missing design documents, we do not know whether the expansion joint was a

requirement. However, based on the industry standards⁶ for design, only very large or very long structures would normally have this type of an expansion joint. Our engineers believe that the existence of this 3-inch wide expansion joint and the fact that it is unreinforced makes the hospital highly susceptible to earthquake damage.

- 1. Identify the contracting officer(s) responsible for oversight of the Salang hospital construction activities and determine:**
 - (a) why the hospital was not built according to contract specifications and acceptable construction standards;
 - (b) why required documents were not placed in the CIDNE database;
 - (c) what disciplinary action, if any, should be taken against the contracting officer(s) who failed to provide required oversight.
- 2. Perform a physical inspection of the building, including appropriate engineering tests and analyses, and, given its location in a high seismic activity zone, determine what corrections are required to ensure the structural integrity of the building.**

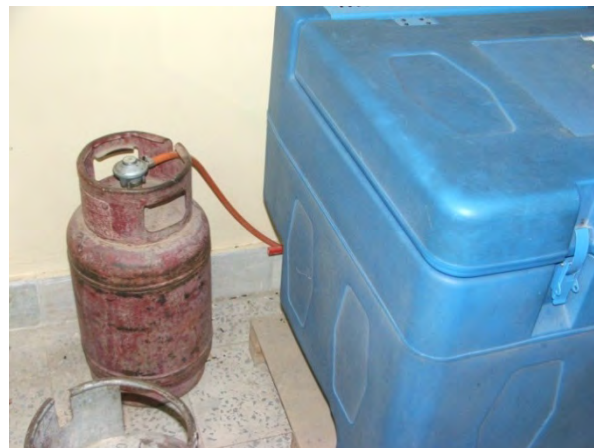
Photo 4 - Propane Supply for Refrigerator

Salang hospital is not providing many of the services it was intended to provide and is operating well below its capacity. As noted earlier, the hospital was designed to provide surgical and X-ray services, a pharmacy, and a laboratory, as well as pediatric, dental and mental health services. Although the hospital treats about 70 patients per day and is open 24 hours a day with staff available for night-time emergencies, it does not and cannot provide many of these intended services. For example, the doctors we spoke to on site confirmed they are not qualified surgeons, and the hospital does not have a functioning surgery unit. In addition, the X-ray machine is stored in a locked room and is not used because parts are missing and there is not enough electricity to operate it. The hospital staff also told us the ministry provides some medicine and vaccines, but without electricity it is hard to refrigerate them. As a "work around" measure, the hospital is using a propane-operated cooler for vaccine storage (see photo 4).

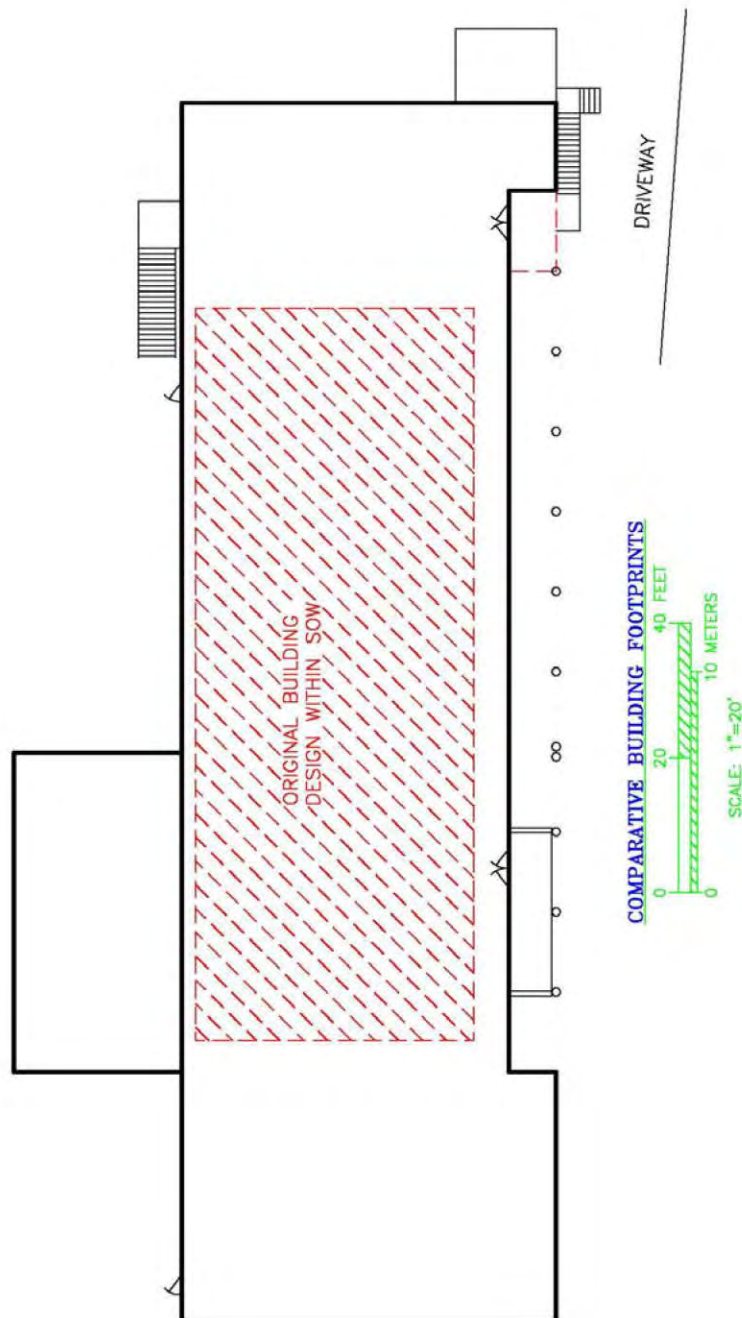
APPENDIX II - COMPARATIVE BUILDING FOOTPRINTS

- The original design drawings called for a one-story, 15-room hospital building; a one-story four-stall toilet facility; and a guard shack. However, we found that a two-story building had been built. It was an 18,300-square-foot structure, more than three times larger than the 5,300-square-foot building called for in the original design plans. We could not find any documentation showing that the Bagram Regional Contracting Center contracting officer had modified the contract to approve the two-story building, as was required under the contract.³ According to a Provincial Reconstruction Team record of a meeting with an Afghan Ministry of Public Health official, the Department of State member of the team stated that the Ministry and the provincial government approved the alternate design; however, no documentation exists to confirm that these officials approved the design. The State Department representative also noted that the alternate design was necessary because the hospital's irregularly shaped lot would not accommodate the design called for in the contract documents. However, it is unclear to us why the lot could not accommodate the hospital as originally designed, but could accommodate a facility that had a larger footprint than was called for under the contract. See Appendix II for a comparison of the originally-designed building's footprint and that of the building that was actually constructed.

Note: The outer black lines show the 9,150 square foot footprint of the 18,300 square foot two-story hospital building actually constructed by the contractor. The shaded red box within the black lines shows the relative size of the 5,300 square foot footprint that the Salang hospital would have occupied had it been constructed in accordance with the designs provided for in the contract. It remains a question as to why the lot was inappropriate for the 5,300 square foot building, but suitable for the 18,300 square foot building.
